FRENCH DRAIN MONITORING AT TOE OF TAILINGS DAM

CASE STUDY

SSR MINING

Seabee Gold Mine,
Saskatchewan,
Canada

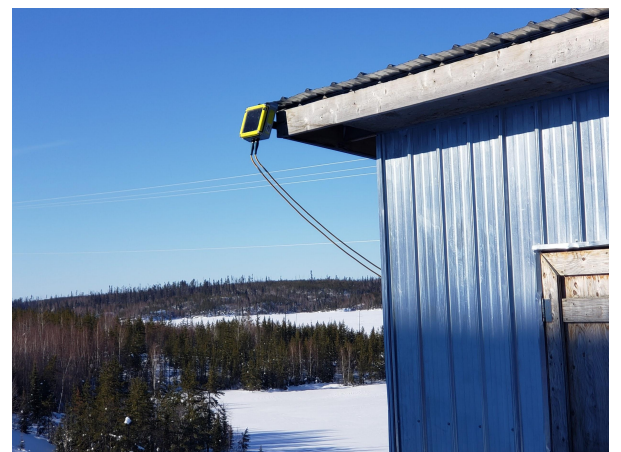
D505 data logger mounted on the sump building roof, collecting data from 2 digital temperature cables.

The cables were attached to a rope and pulled through an existing conduit, which was made possible by the small 11mm diameter of the digital temperature cable. Both cables were connected to a single D505 data logger, located at the sump, with satellite telemetry to collect the data in real-time.

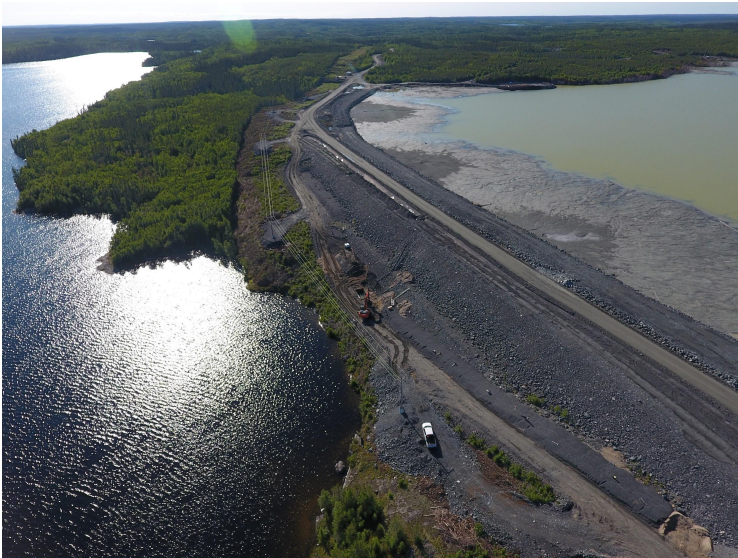
Aerial image of the tailings dam with the adjacent lake shown on the left.

One of the tailings management facilities at Seabee Mine was built adjacent to a lake. It was discovered that impounded water was seeping out of the dam towards the lake. To protect the lake from the untreated water, a French drain was installed at the toe of the dam down to bedrock and it included analog thermistor strings to ensure the drain would not freeze over the winter. If the drain were to freeze, there was a risk of seepage entering the lake. All water collected in the drain went to a sump to be pumped back into the facility. The analog thermistor strings installed produced erroneous data sets and eventually failed, which was attributed to corrosion of the conductors.
